**VISUAL CONFIRMATION OF VOICE TAKEOFF CLEARANCE (VICON)  
OPERATIONAL EVALUATION: VOLUME I**

FEDERAL AVIATION ADMINISTRATION TECHNICAL CENTER  
Atlantic City Airport, N.J. 08405

**FINAL REPORT**

**FEBRUARY 1981**

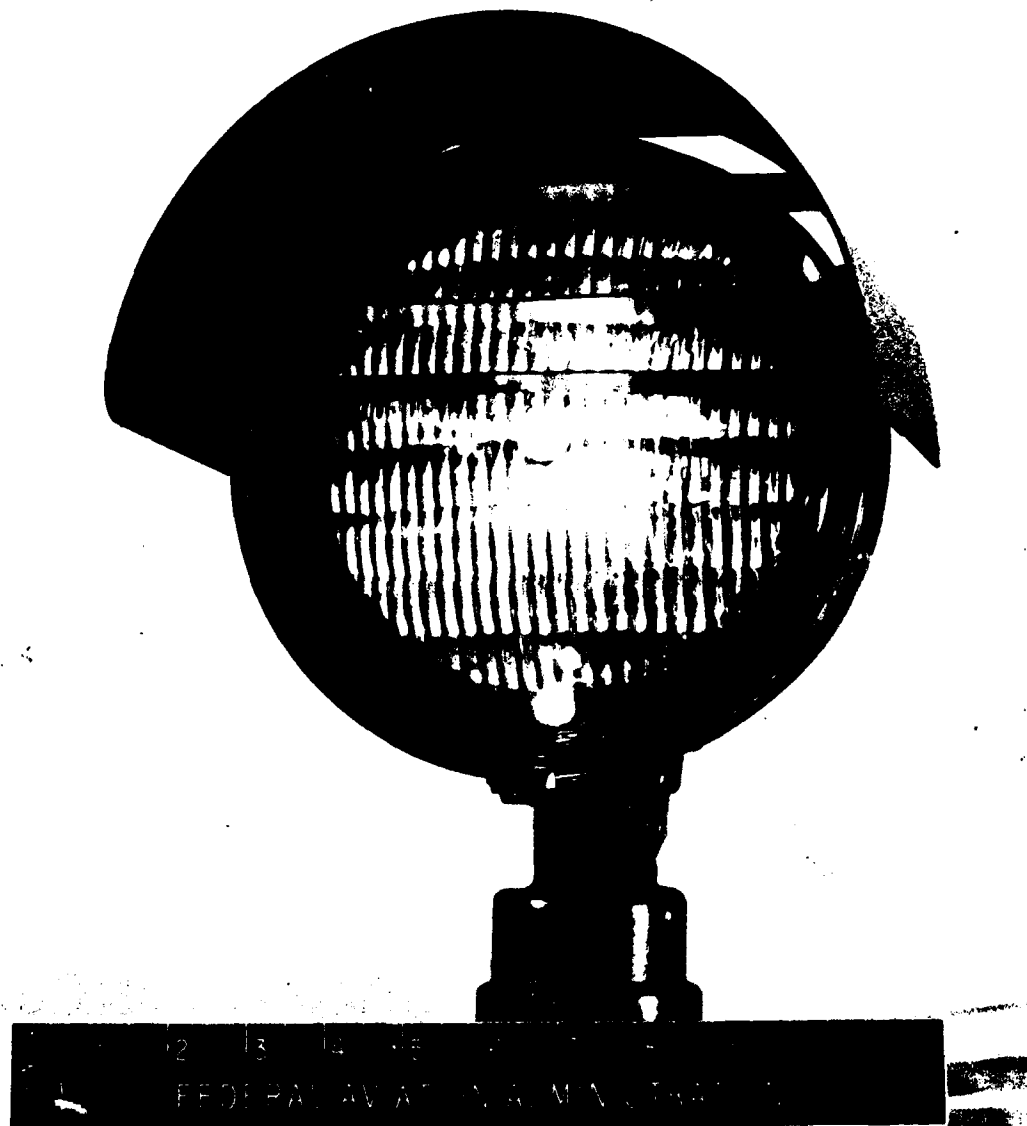
FIGURE A-2. LOUVERED SUN SHIELD (5-INCH VISOR)

5-inch visor became unacceptable at a height of 38 feet. These tests were conducted on a clear day in bright sunlight. Not only ATCS's, but also electrical engineers and technicians, were present.

A check of the pilot questionnaires, which were received after installation of the sun shields, indicated only one adverse comment regarding sunglare on the VICON lights. Unfortunately, the pilot did not provide his departure point; therefore, it could not be determined if he had used a departure location where the sun shields were being utilized or one of the departure points which had no sun shield. These tests indicated that both sunglare shields successfully eliminated the glare problem, and both were visible from all types of aircraft unless the aircraft cockpit was 36 feet or higher above the ground and 50 feet or less from the VICON light cluster. This would accommodate most runways which would be utilized by wide body aircraft. Since both sun shields were found effective in eliminating the glare during the test, it would seem feasible that the shield with the 5-inch visor be recommended for use in the future.
